CHEMICAL ANALYSIS OF THE POLYESTER/METAL SURFACE OF A DELAMINATION FAILURE

Eldridge M. Mount III
EMMOUNT Technologies
Fairport, NY, 14450
United States

Abstract

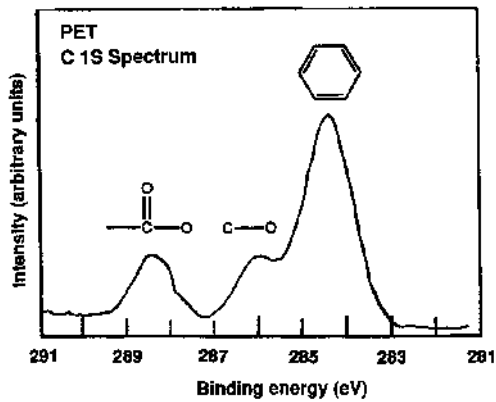
Figure 3a: Oxygen 1S spectrum for PET

Figure 3a and 3b shows the typical high resolution oxygen and carbon 1S spectra for a PET polymer surface. In figure 3a we note the symmetrical peaks for the C-O and C=O 1S spectra due to the equal number of C-O and C=O functional groups in the PET molecule.

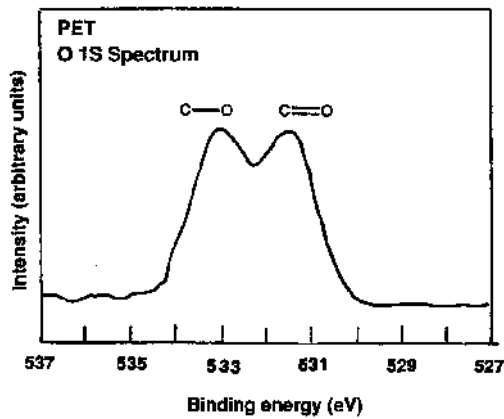
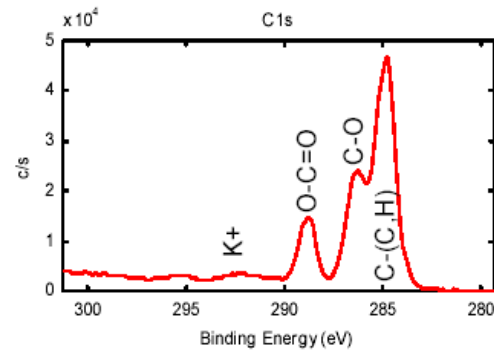
Figures 4a ,4b, 5,a, 5b, 6a & 6b show the high resolution XPS oxygen and carbon 1S spectra for the exposed PET surfaces of samples 1, 2 & 3 respectively. It is clear from these figures that the PET surface of samples 2 & 3 has been chemically changed from the native PET polymer surface.

It is clear from the XPS analysis of the good (sample 1) and bad (samples 2 & 3) laminations that the metallized PET surface of samples 2 & 3 have been chemically modified in some fashion which is increasing the concentration of C-O species at the film surface. This is perhaps indicative of an increase in acid O=C-OH and/or glycol C-OH end groups on the PET surface. This would imply that the PET surface has been reduced in molecular weight or that it contains an increase in reduced molecular weight PET which would be consistent with the presence of a weak boundary layer at the PET film/metal interface giving rise to the decreased bond strength and the increased metal lift in laminations 2 & 3. This chemical change of the PET surface was not seen in sample 1 which exhibited acceptable lamination bond strength.

Figure 5a & 5b: O1s and C1s spectra of exposed PET from sample #2 spectra showing excess C-O relative to typical of PET polymer surfaces

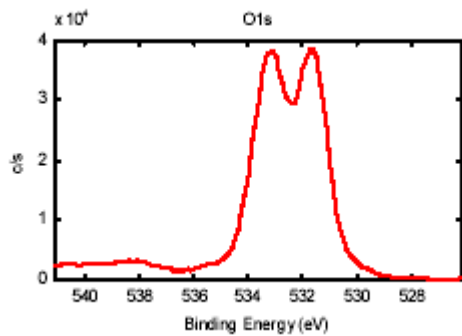
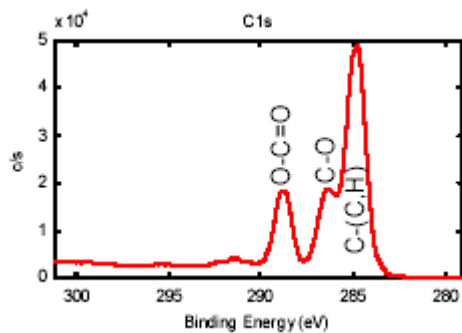
Figure 4a & 4bb, O1s and C1s spectra of exposed PET from sample #1 showing spectra typical of PET polymer surfaces

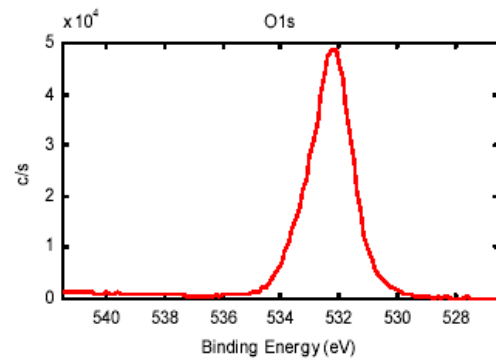
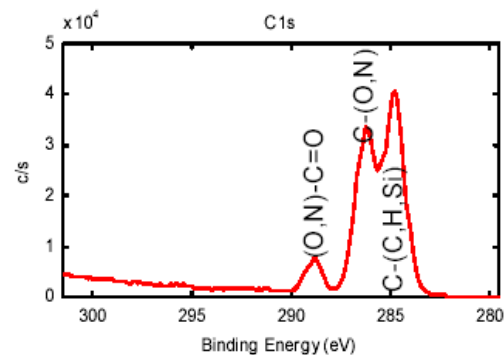
Figure 6a & 6b: O1s and C1s spectra of exposed PET from sample #3 spectra showing excess C-O relative to typical of PET polymer surfaces
