CHEMICAL ANALYSIS OF THE POLYESTER/METAL SURFACE OF A DELAMINATION FAILURE

Eldridge M. Mount III
EMMOUNT Technologies
Fairport, NY, 14450
United States

Abstract

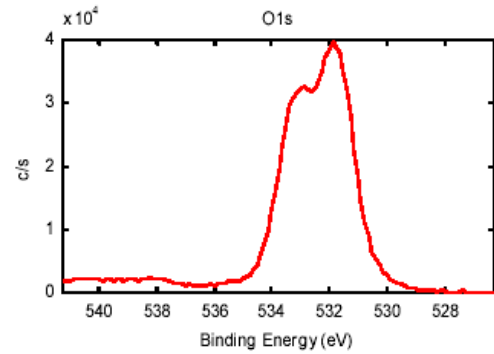
Figure 5a & 5b: O1s and C1s spectra of exposed PET from sample #2 spectra showing excess C-O relative to typical of PET polymer surfaces
